**EXPERIMENT DEFINITION PHASE  
SHUTTLE LABORATORY**

**LDRL-10.6 EXPERIMENT**

**SIXTH QUARTERLY REPORT  
AND  
TWELFTH MONTHLY REPORT**

**NASA Contract NAS 5-20018**

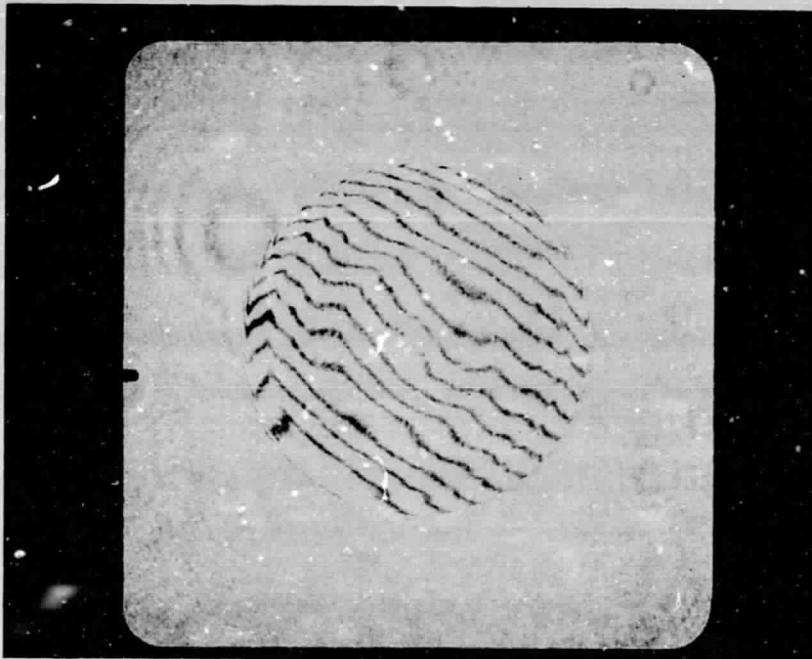
60097-6

Figure 6 is the beryllium primary mirror interferogram. Measurements on this element were made using a HeNe laser 8-inch interferometer, operating at  $0.633 \mu\text{m}$ . The pictures clearly show zones where the radius of curvature abruptly changes, although the changes are small. The disadvantage of this form of error is that it is systematic rather than random, but

FIGURE 6. ELEMENT 3-PRIMARY MIRROR

it is hoped that the magnitude will make the problem insignificant. Further tests will be made on this mirror before installation (see below). The data for this mirror is summarized as follows:

Diameter	7.236 inches
Focal length	10.636 $\pm$ 0.001 inches
Centering	<0.005 inch
Radius of curvature (vertex)	21.272 $\pm$ 0.002 inches
Overall deviation	1-3/4 fringes
Local smoothness	<2 arcsec (95% c.a.)
Astigmatism	1 fringe
Surface finish	60/40
Back surface	Parallel to 0.001 inch

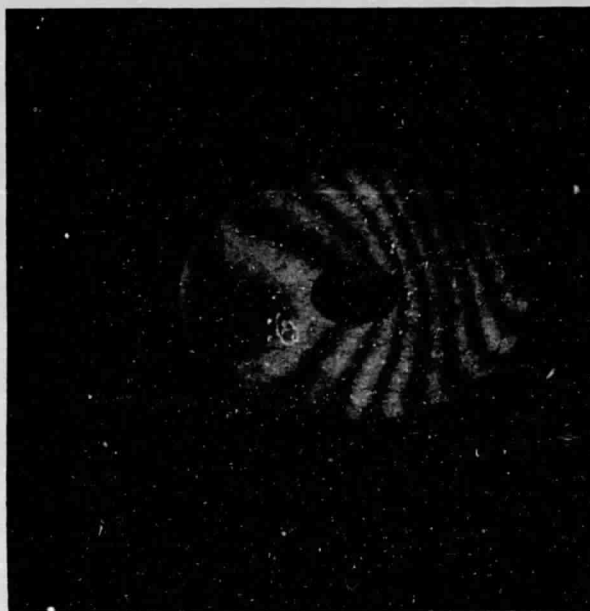
60097-8

Figure 8 is the small beryllium folding mirror (element 5). This element establishes the obscuration ratio for the system, and the edges of the center hole must be as sharp as possible. It is evident that the efforts expended to maintain good edge quality were successful, as no rolloff can be seen. The 1 mm allowance for this effect is clearly conservative, and the true obscuration ratio of the system should be less than originally planned.

FIGURE 8. ELEMENT 5-SMALL BERYLLIUM FOLDING FLAT

The data sheet for element 5 shows a deviation of 2 fringes concave, astigmatism of 1/2 fringe, and a surface finish of 60/40. Test wavelength was 0.589  $\mu\text{m}$ .

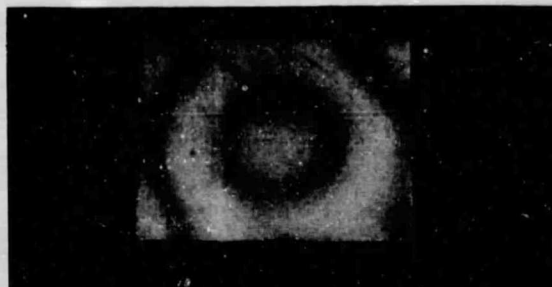
Figure 9 shows the small aluminum folding elements 6 to 9. All pieces are within 1-3/4 fringes overall, show less than 2 arcsec smoothness, astigmatism of 3/8 fringe or less, and surface quality better than 80/50. Test wavelength was 0.589  $\mu\text{m}$ .

FIGURE 9. SMALL ALUMINUM FOLDING ELEMENTS

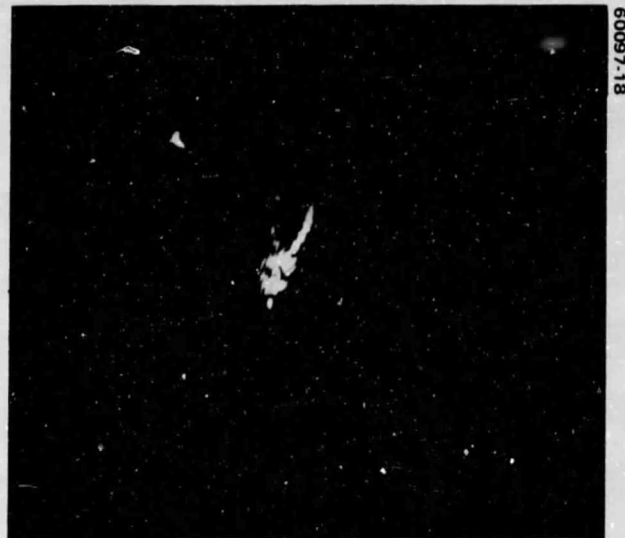
Unfortunately, the pattern for the entire receiver was not recorded as a satisfactory technique had not been developed at this early date. The first pattern that was recorded is shown in Figure 15, which is for the primary mirror only. A two lobed pattern with severe coma is shown. The entire receiver was very similar but there were two additional tails caused by the IMC mirrors.

FIGURE 15. FAR FIELD PATTERN; OF PRIMARY MIRROR BEFORE REALIGNMENT (NO CALIBRATION)

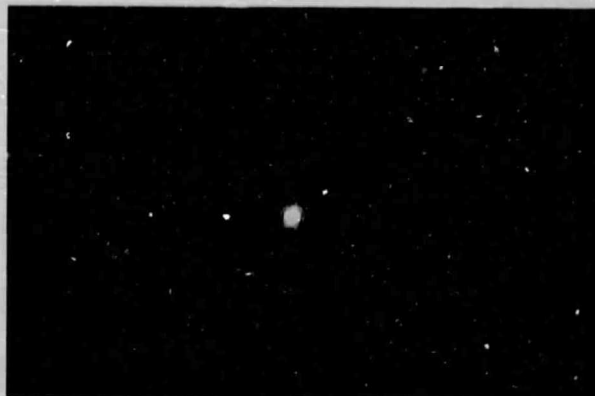
60097-19

Figure 16 shows the pattern obtained from the two test lenses used in the other setups. For this photo, the listed Airy diameter is that expected for  $0.63 \mu\text{m}$ . The results clearly show that the tests were not limited by the test lenses.

- $f/8$
- $M = 280$
- AIRY DIAMETER = 0.101 in.  
AT  $0.63 \mu\text{m}$

FIGURE 16. REFERENCE OPTICS CONSISTING OF TWO TEST LENSES

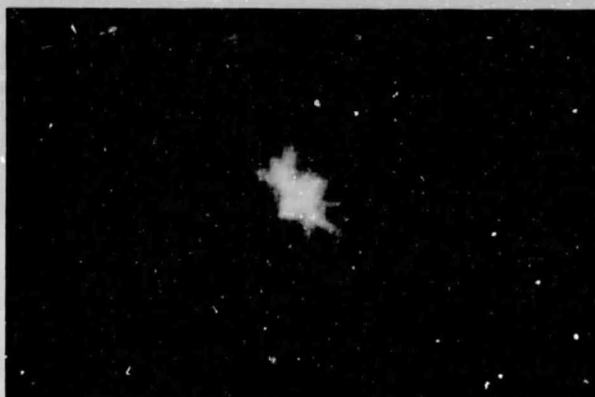
60097-20

Figure 17 is the pattern from the primary mirror after careful alignment to obtain a symmetrical pattern. Most of the energy falls within the 0.7-inch Airy diameter, but there is "ghosting" around the pattern. The comatic tails evident in Figure 15 are still there but are more nearly symmetric and lower in amplitude.

- $f/2.2$
- $M = 314$
- AIRY DIAMETER = 0.70 in.

FIGURE 17. PRIMARY MIRROR PATTERN

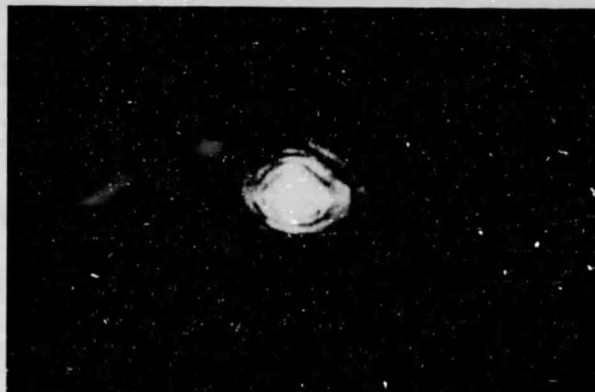
60097-21

- $f/8$
- $M = 260$
- AIRY DIAMETER = 2.12 in.

FIGURE 18. SECONDARY MIRROR PATTERN

Figure 18 is the pattern for the elliptical secondary illuminated at its primary focus by a point source. Here nearly all of the energy falls within the 2.12-inch Airy diameter, and in fact a visible diffraction pattern (Airy = 0.13 inch) has almost formed. Again, there is significant ghosting or scattered energy.

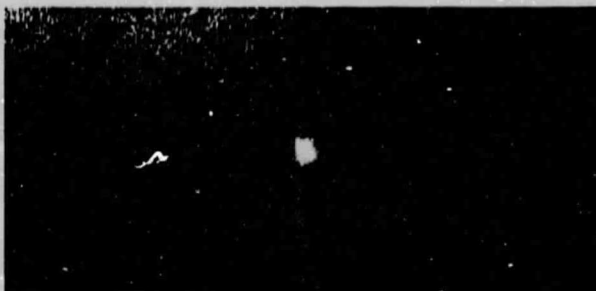
- $f/8$
- $M = 45$
- AIRY DIAMETER = 0.37 in.

FIGURE 19. PATTERN FOR PRIMARY, SECONDARY, AND TWO FOLDING MIRRORS

Both the primary and secondary mirrors show some astigmatism, so an attempt was made to align the two mirrors for cancellation as the mirrors were reinstalled into the housing. Figure 19 shows the results of careful alignment of the first four elements of the optical train consisting of the gimbal mounted pointing mirror, primary, secondary, and small folding mirror following the secondary. Figure 19a shows the pattern in sharp focus, while Figure 19b was taken with a longer exposure to illuminate the screen. The circle in Figure 19b approximates the  $10.6\text{ }\mu\text{m}$  Airy diameter and shows that the basic optical train of the receiver is capable of concentrating virtually all of the received energy within this circle.

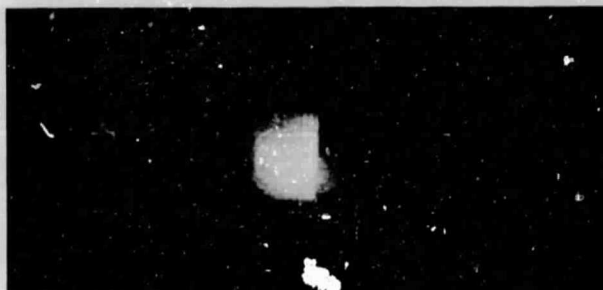
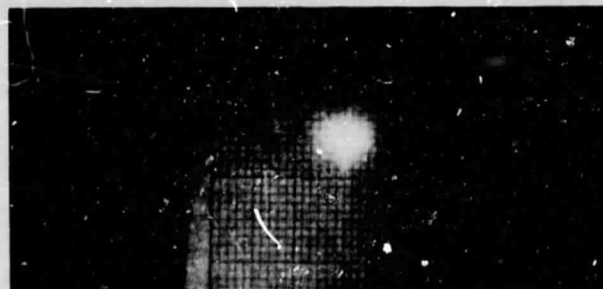
- $f/8$
- $M = 96$
- AIRY DIAMETER = 1.67 in.

FIGURE 20. LOCAL OSCILLATOR COMBINING MIRROR PATTERN

The excellent results obtained on the basic telescope are encouraging; the system problems are concentrated in the relatively inexpensive flat optics consisting of two IMC mirrors and the local oscillator mirror. Figure 20 shows the local oscillator combining mirror. The top photo is an interference pattern; the lower photo is a far field pattern. There is a curvature in the mirror probably caused by the epoxy mount, and there is also a slight amount of astigmatism. The far field pattern confirms the quality of this element, as all of the energy is concentrated well within the  $10.6\text{ }\mu\text{m}$  Airy diameter.

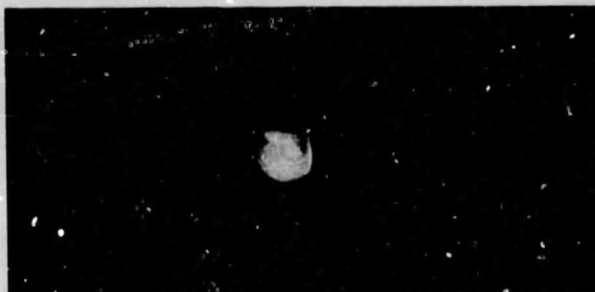
DOUBLE PASS INTERFEROMETER TEST SETUP

- PATTERN SHOULD BE ROUND
- DISTORTION CAUSED BY SEVERE MIRROR DISTORTION

FIGURE 21. INTERFERENCE PATTERN FOR TWO IMC MIRRORS

Finally, the two IMC mirrors were measured. Due to the difficulty in aligning these elements, they were not removed from the optical bridge but were tested together. Figure 21 shows the method used to obtain a double pass interferometer measurement and the results of the test. The distortion in these two elements is so severe that an accurate fringe count could not be obtained. Even using a path length as short as physically possible, the far field pattern from these two elements was beginning to form, as evidenced by the distortion in Figure 21.

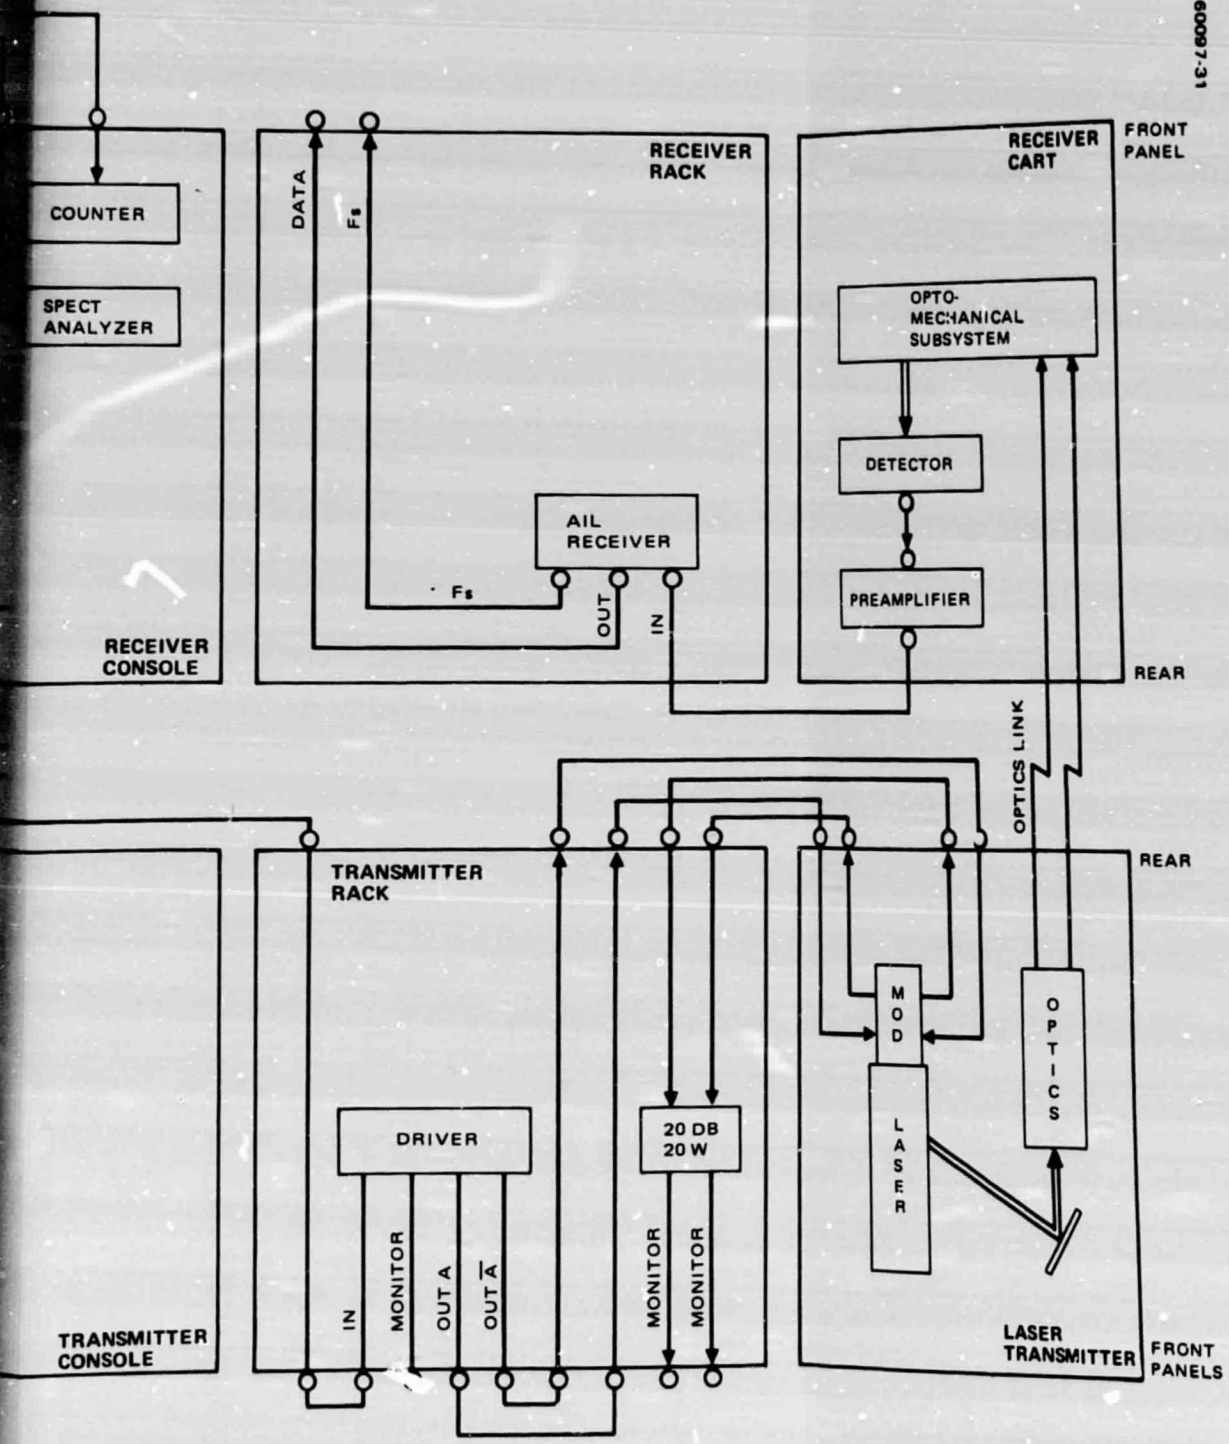
FIGURE 26. SIGNAL PATH INTERCONNECTIONS

Figure 25 is a NASA photo of the two test consoles. Figure 26 is a signal path diagram for the two consoles, two relay racks, laser transmitter, and 10.6  $\mu\text{m}$  receiver.
